MONITORING OF AN ARTIFICIAL TURF FOOTBALL PITCH WITH RECYCLED ELT RUBBER INFILL

Assessment of risk management measures to prevent the release of microplastics

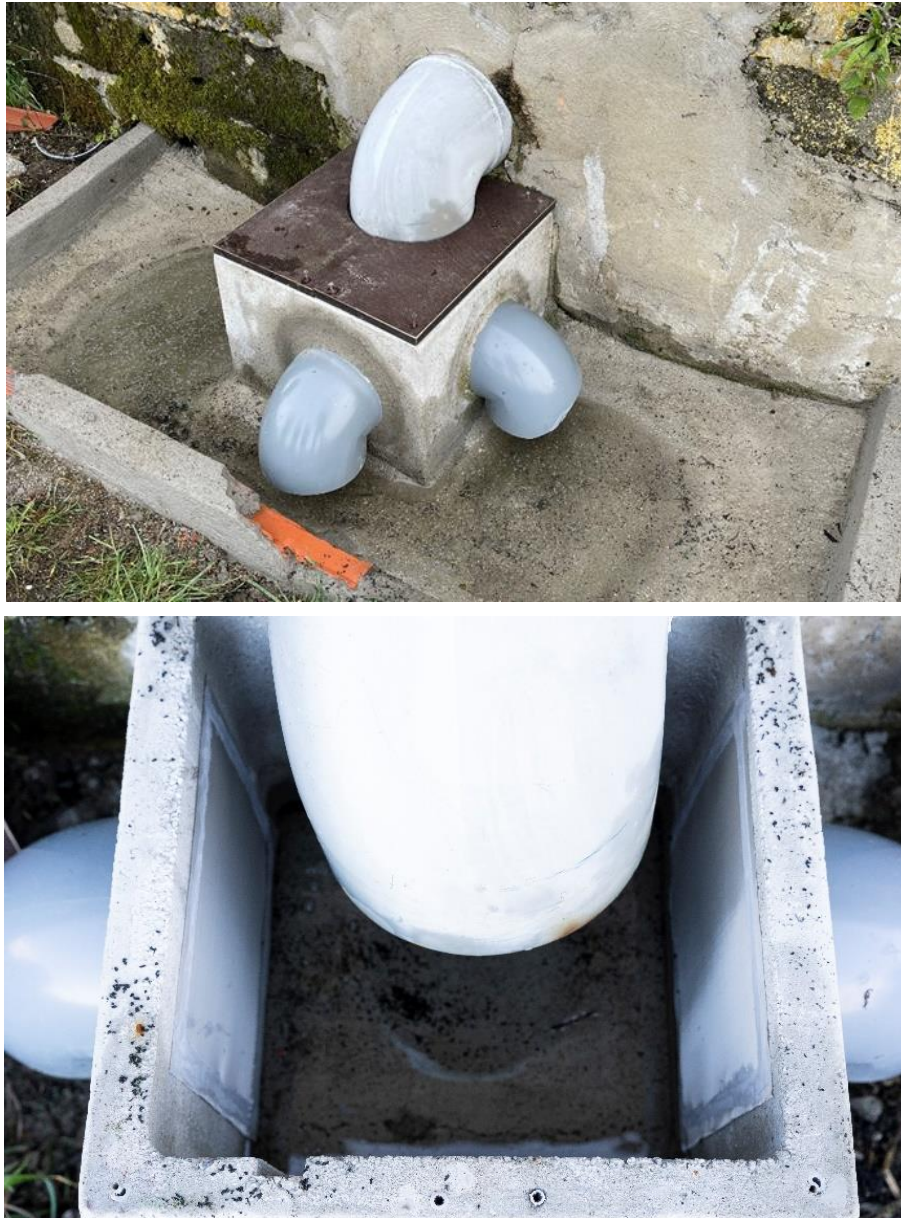
Image 4: Manhole and filters of 100 μm at the general drainage.

As mentioned below, the general drainage is being redesigned in order to increase its draining capacity, which has been reduced by the installation and clogging of filters.

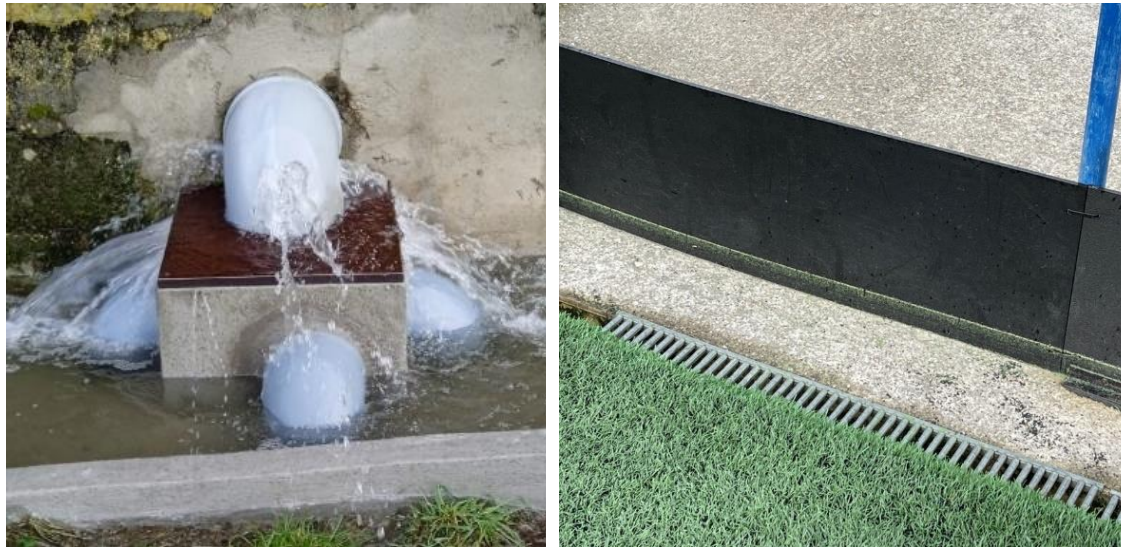
Among these incidents, it is necessary to mention the clogging of the filters of the general drainage manifold, mainly due to the accumulation of fine particles of polyethylene fibres from the artificial turf, which in short periods of heavy rain causes the flooding of part of the pitch due to the lack of drainage capacity.

Image 11: Clogging of the filters of the general drainage manifold during short periods of heavy rain (left) and marking on the fencing panels of the water level reached during flooding (right).

The general drainage manifold is currently being improved in order to increase its drainage capacity and to prevent microplastics from the artificial turf filament clogging the filters.

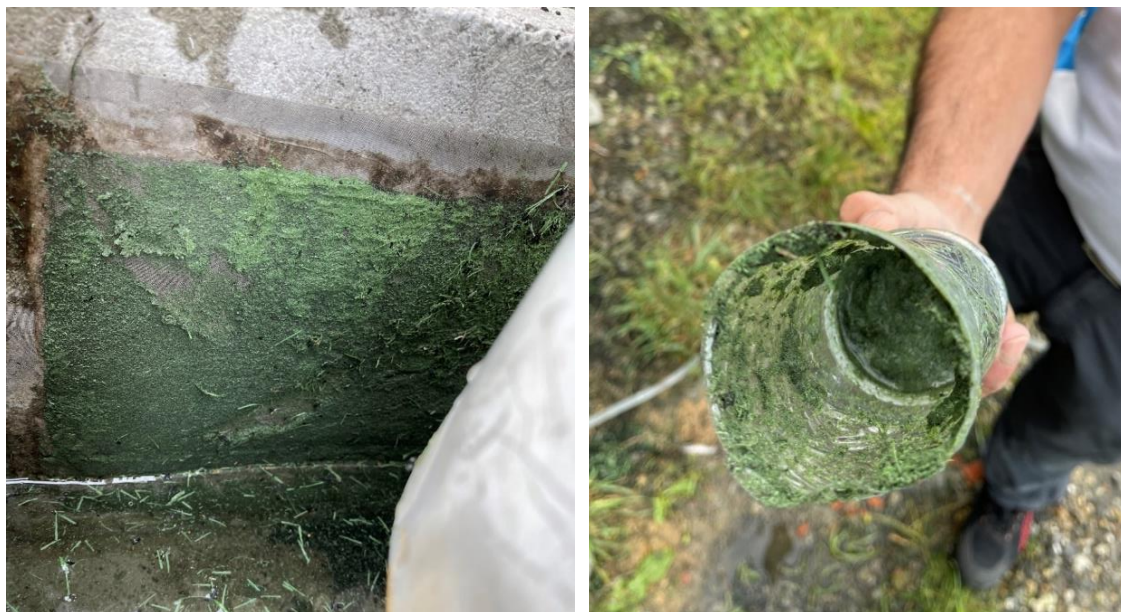
Image 12: Clogging of the filters of the general drainage manifold mainly due to the accumulation of fine particles of polyethylene fibres from the artificial turf.

- An **improved design of the drainage capacity of the general drainage manifold** is necessary, because in short periods of heavy rainfall there is clogging of the filters mainly caused by fine polyethylene particles from the artificial turf.
